Case study: Paste plant retrofit

SUMMARY: A zinc, copper and lead mine located in Canada has recently restarted operations after several years under care and maintenance. The mine had an existing paste plant that was historically used for surface tailings deposition. The existing paste plant was overhauled and retrofitted to be able to handle full plant tailings and produce cemented pastefill that will achieve the required target strengths underground. In this case study, the various design challenges faced and lessons learned are documented which led to the successful retrofit of the paste plant in 2019.

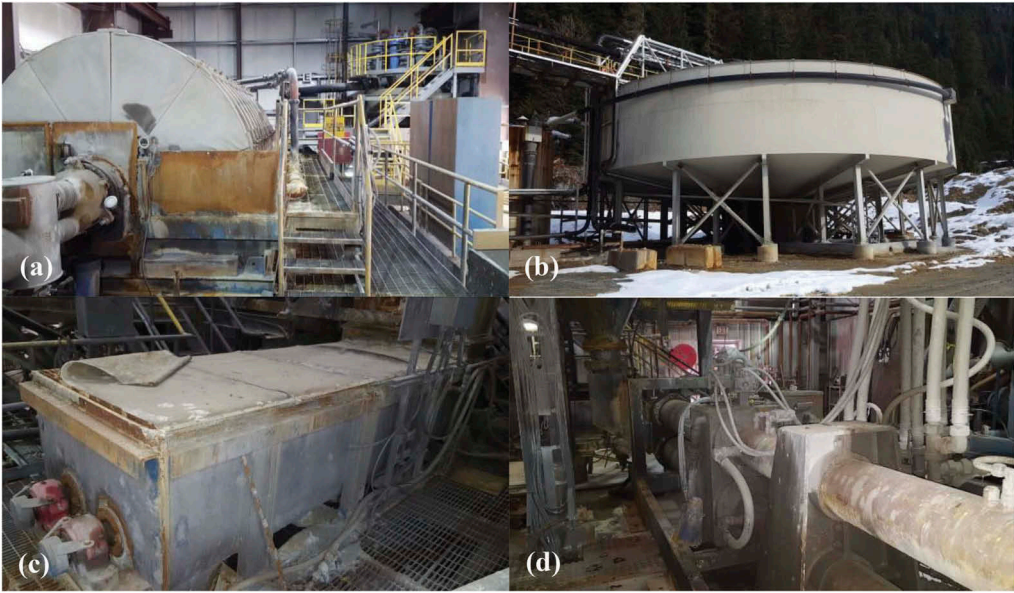
Figure 3. Photos of existing paste plant, (a) view of disc filter (left) and cyclones (right); (b) view of thickener adjacent to paste plant; (c) continuous mixer; (d) positive displacement pumps.

During on-site visits, the paste produced by the existing mixer was witnessed to be full of lumps (filter cake). The filter had a very short residence time (~30 s) and was inadequate to ensure quality backfill production due to low energy input. It was also unlikely that the mixer would be able to adequately disperse the binder and produce a high-quality paste. A low-profile twin-shaft mixer was installed with a residence time of ~2.5 minutes. The new mixer was installed on a new lower steel platform.

Upon inspection of the two existing piston pumps, it was found that these pumps would need to be replaced due to the poor condition they were in. The associated hydraulic power packs were refurbished and reused. The new PD pumps were moved to align with a new paste hopper.

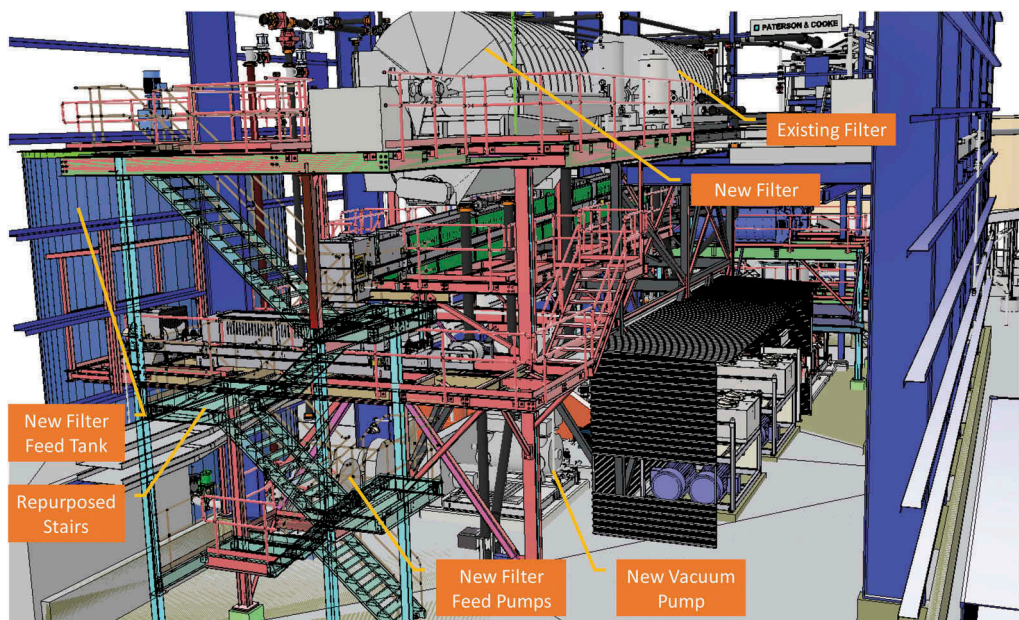
Figure 5. New extended support structure (Indicated as red) for second vacuum disc filter.

The support structure was extended to support the second filter (Figure 5 & 6). The existing flocculant plant was moved to where the cyclone underflow tank was located previously while the existing west staircase was moved over against the west side of the building. The new structure allows top access to the filter feed tank and agitator.

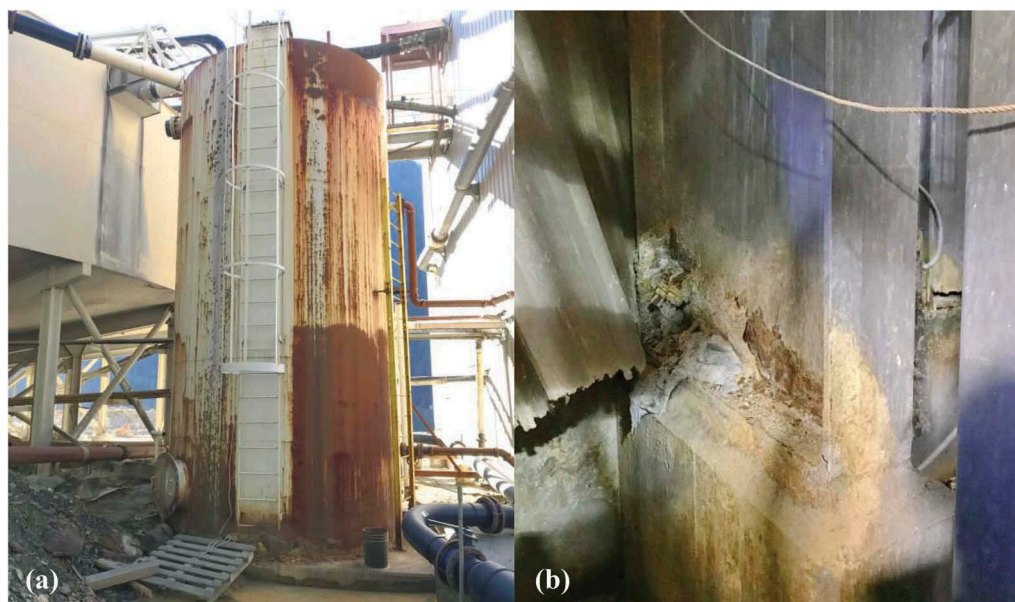
The process water tank had substantial corrosion and required a more involved remediation or complete replacement. The tank was opened to facilitate sandblasting and painting of the interior. An initial inspection of the tank interior was not done as all the inspection hatches were inoperable due to corrosion. As such, once the process water tank was opened, it was discovered that it was more than half full of tailings. Again, the use of a vacuum truck, pressure washers and labourers were employed to empty the tank.

Initial inspections were conducted to determine the condition of the structure, equipment and tanks that would be reused in the retrofit. While most of the structure was in good condition, any steel that had been in contact with tailings was corroded and required remediation (Figure 7). Fortunately, the equipment and structure with the most significant corrosion and those that had seen resourceful repairs by plant staff were to anyway be replaced by new equipment and structural steel as part of the retrofit. These included the filter cake conveyor, paste mixer and mixer platform structures. The remaining structural members that had minor contact with tailings spillage were sand blasted or wheel abraded in place and coated with a two-part epoxy to protect from future exposure.

Figure 7. Examples of existing equipment corroded from contact with tailings (a) Process water tank and (b) Building column.

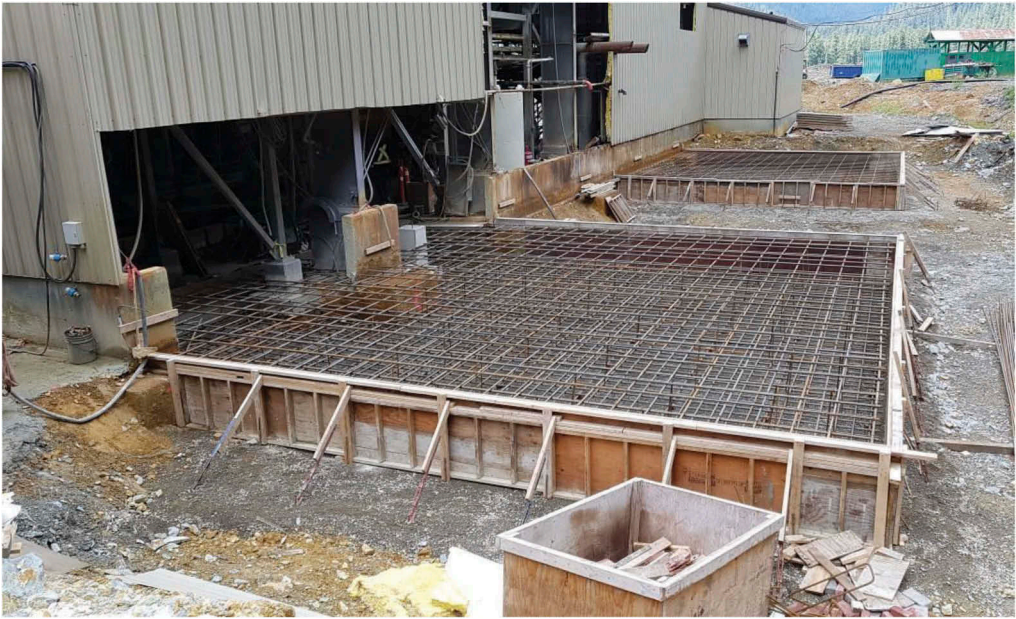
The silo layout was based on geotechnical assumptions before the commencement of the detailed design and the allowable soil loads could be determined. When past geotechnical data and reports were reviewed, it was found that the existing plant subgrade was largely fill material and the existing building and equipment footings were placed on dynamically compacted subgrade. Furthermore, the densification required for construction was performed only in areas where the footings were constructed in 2002 and the condition of the surrounding grade was unknown. A follow-up geotechnical investigation confirmed that the soils were composed of “*mixed organics, mine waste rock, and other mine waste materials*” to a depth of 3.3 m and limited the allowable soil bearing capacity to 75 kPa.

The design challenges that were faced with the binder silo foundation also created additional construction challenges. In order to properly construct the foundation, the stem wall to the building had to be cut out and removed and the floor in the north east corner of the plant was saw-cut and removed. Rebar for the silo foundation was specified as Ø25 mm bar, layered at ~200 mm spacings. To effectively tie the foundation into the interior structural footings, it was necessary to extend the bar into the building and dowel into the existing concrete before pouring new concrete around it (Figure 8).

Figure 8. Silo and filter feed tank raft footings.

As per the geotechnical findings and resultant loads, calculations required a raft footing of 10.7 m by 10.2 m to resist to overturning moment of the relatively tall silo and high load. The site layout, however, set the distance from the centreline of the silo to the outside of the existing building to only 3.345 m. This accordingly required that the silo foundation to encroach into the building by over 2 m via concrete and rebar to tie into the structural steel supporting footings on the building’s interior. When the need for a large raft footing was determined, a design review was called to determine alternatives. Options reviewed included silo relocation, pile foundations and anchoring to a nearby rock slope. In the end, the raft footing design was retained which resulted in construction sequence modifications.

It was essential that the concrete forming the binder silo foundation was isolated from the building footings while still being fully tied into the upgraded structural steel supporting footings. This was done to avoid complex interactions with the new footings, potential problems due to differential settlement and the need to update to current building and seismic codes.

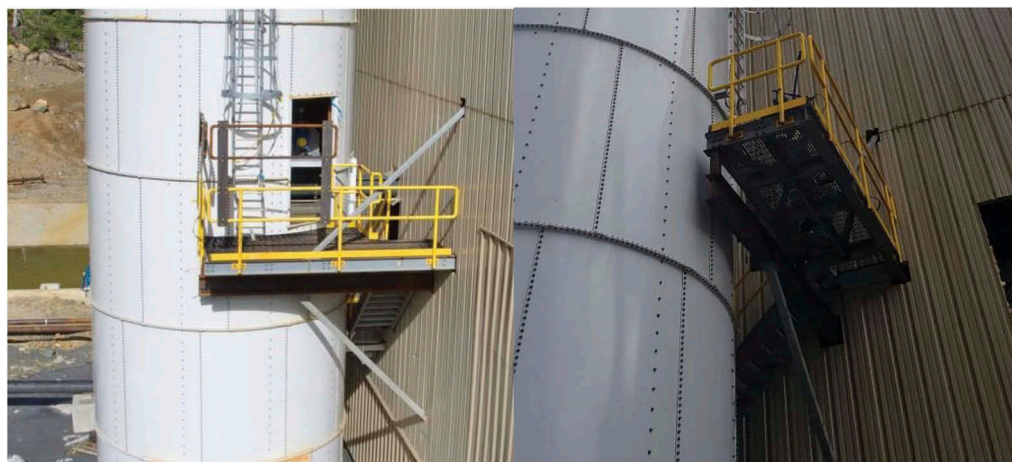
The challenges associated with the design of the cantilevered access platform were realized because the precise location of the silo could not be predicted by the design team, partly because of the necessity to situate the base ring wherever the anchor bolts could be drilled around the rebar in the concrete. The resulting stair and platform (Figure 9) are functional although it required site modifications to limit the deflections and minimize the gap between the platform and silo entrance.

Figure 9. Cantilever staircase to access binder system.

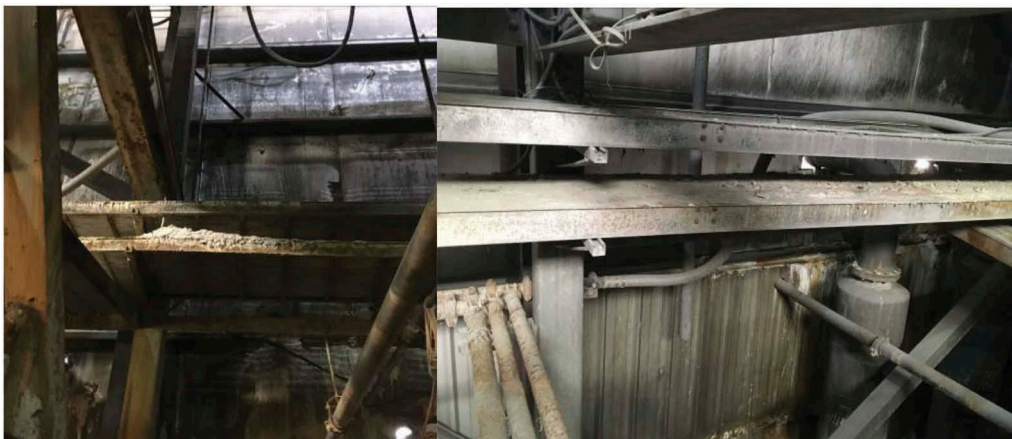
The inspection of the cable runs revealed that the cable trays were both overloaded and covered in tailings. Large sections of cable trays were replaced due to poor condition arising from corrosion (Figure 10). Electrical cabling suffered the same fate with large quantities of it being replaced due to cracked sheathing and great difficulties in identifying which cables were in good conditions and which not. The poor condition of the cables and trays in the plant ended up being significant both in terms of cost and having a negative impact on the project schedule.

Figure 10. Cable tray's full and corroded/full of tailings.
