# Lessons Learned from Tight or Blind Filling Induced Barricade Failures

## Abstract

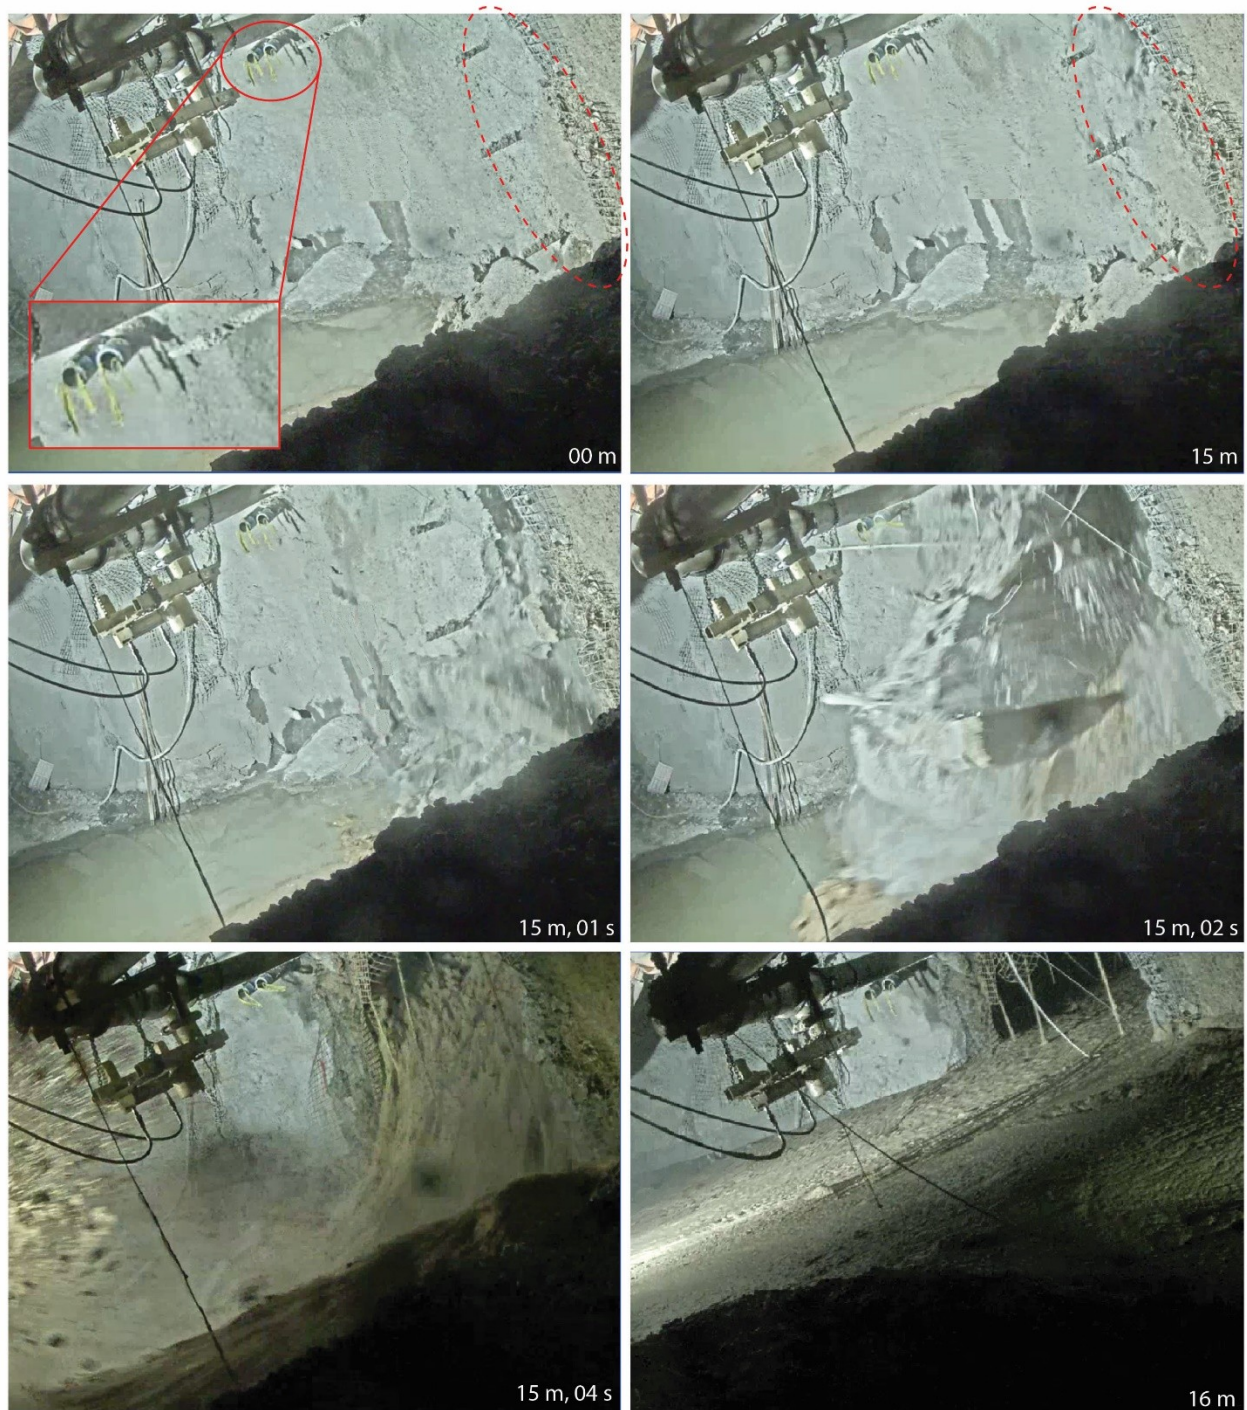
Figure 2. Images showing barricade failure. The solid circle shows breather pipes with flags to indicate air flow, and the dashed circle highlights initial movement.

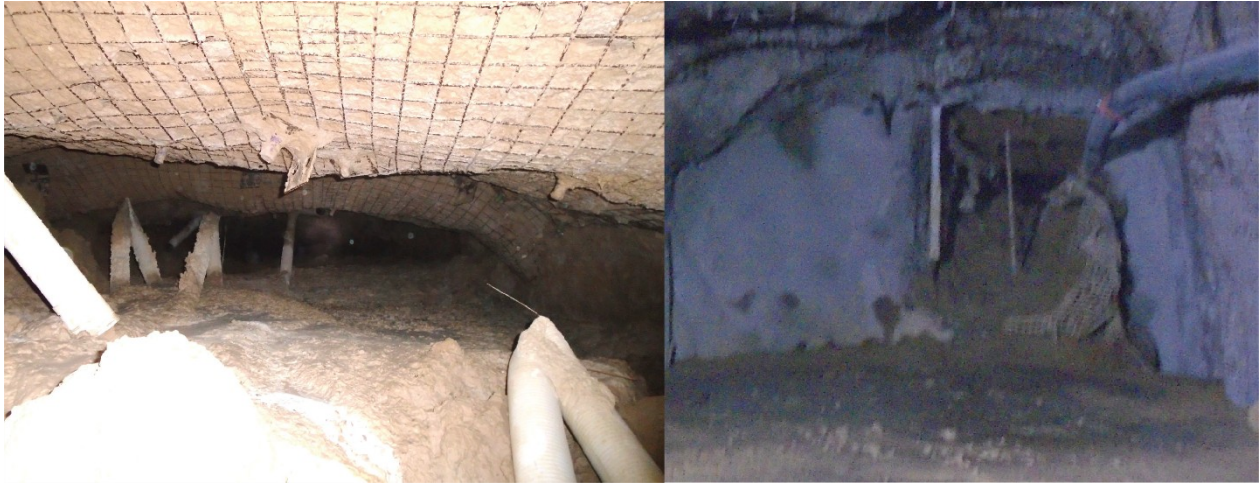
Excess volume was placed ( $1100 \text{ m}^3$  vs  $\sim 900 \text{ m}^3$ ) and the barricade failed prior to any material flowing through the breather pipes (Figure 2). A contribution to the barricade failure may have been vibration of the paste pour pipe which was chained to back. Three breather pipes of diameter 10 cm were installed; an investigation suggested they had been crushed.

Figure 2. View within the drift showing volume of remnant backfill and bent breather pipes (left); the barricade failed on one side (right).

- Establish placement volume limits.
- Tightly secure the fill pipe through the barricade.
- Use breather pipes made from competent material to resist crushing with minimum 15 cm diameter.
- Use a minimum of three breather pipes, staggered within a drift, and ensure the point of highest elevation is identified in stope design packages as a potential fill/breather point.
- Tightly secure fill and breather pipes to the back (as in-stope videos from an earlier stope showed paste moved the pipes during filling).
- Place flags on the ends of breather pipes to indicate air flow.

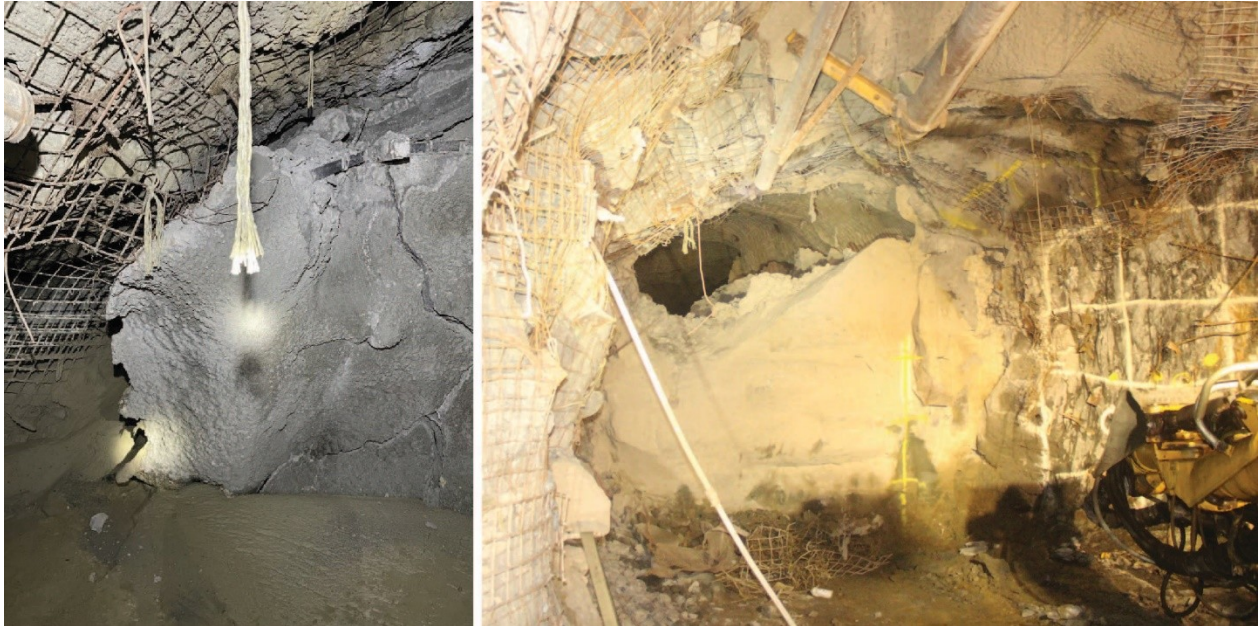
A barricade was constructed at the overcut access of a stope with similar configuration to Figure 1b. The barricade construction process was non-ideal, with the prefabricated falsework frame suffering mechanical damage, resulting in partial detachment from the (NW) sidewall. This issue was exacerbated by potentially inadequate shotcrete thickness in the location of a reinforcing 'corbel' on this NW sidewall due to the close location of a remote mucking stand which obscured the view of the shotcrete applicator. The barricade failure is assumed to have been caused due to the fill height exceeding 5 m above the barricade and reaching the borehole, resulting in a 40 m fluid head elevation. The total volume of paste released due to the failure event is difficult to determine as excess flushes were conducted to 'weaken' the spilled paste, which itself caused problems during clean up. Paste above the 2/3 height of the 5 m tall barricade was released from the stope. Images of the fractured barricade, and subsequently deconstructed barricade are shown in Figure 5.

Figure 5. Images of the displaced barricade which was subsequently partially dismantled to reveal paste above the 3/4 barricade height had been discharged either during the original displacement, or the subsequent extensive flushing.

- Remote access camera and barricade instrumentation would have enabled faster shutdown and easier clean up. These are used at undercut barricades, and are now required at overcut barricades, with an additional pressure sensor at the base of the wall recommended to better define and calibrate fill height versus volumes placed.
- Filling into the stope is via a hopper into the borehole (into the stope), with the hopper providing the disconnect between the pipes to surface to limit potential head pressures.

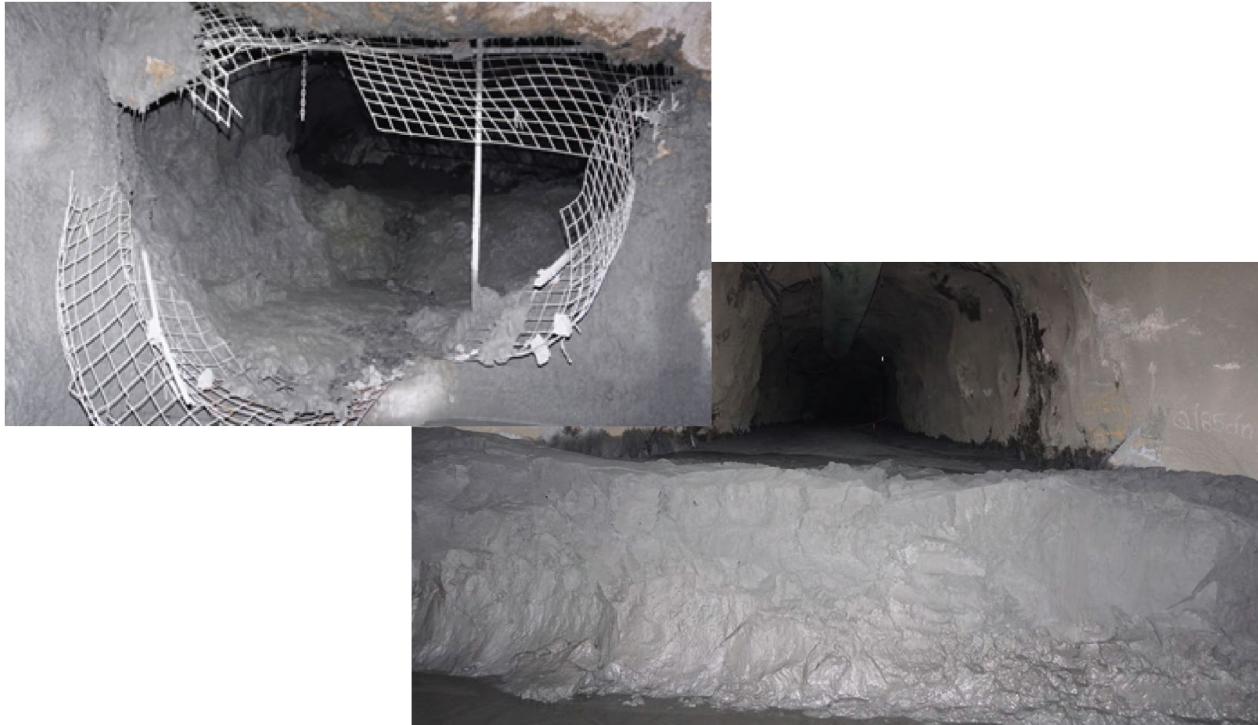
A high-energy release of paste occurred due to a tight-fill induced barricade failure. Paste flowed 100 m from the barricade, over a catchment berm 30 m from the barricade, continued 50 m past a right-angle turn, and proceeded another 50 m past another right-angle turn. Approximately 1 m of fill height required removal from the 100 m distant intersection (Figure 6).

Tight-filling occurred to an approximate height of 5 m above the overcut barricade (analogous to the Figure 1b scenario). Breather holes were installed (vertically) which provided adequate air pressure relief during filling, but once the stope was full pressure within the paste exceeded the barricade capacity. Paste in the fill hole was hypothesized equal to a 30 m paste head equivalent to 700 kPa. Fresh paste behind the barricade was able to flow further than expected.

Figure 6. Failed barricade and paste excavated from intersecting drift an estimated 100 m from the barricade (From Gray, 2019).

- Install two 'spill holes' of 10 cm diameter and 0.5 m from the top of overcut (crown) barricades; these positions marked the limit of the initially placed backfill height. This paste volume below the spill holes should be allowed to cure to control the potentially flowable volume of paste within tight-filling spaces, and termed a 'stop and cure process'.

- Containment / exclusion zones should be equal to the maximum volume of the potentially fluid paste. There was realization that the potential for high barricade pressures was underestimated as was the potential for paste to flow significant distances. A key take-away was that low likelihood risk should not lead to complacency in design.
