Case study: Paste plant retrofit

SUMMARY: A zinc, copper and lead mine located in Canada has recently restarted operations after several years under care and maintenance. The mine had an existing paste plant that was historically used for surface tailings deposition. The existing paste plant was overhauled and retrofitted to be able to handle full plant tailings and produce cemented pastefill that will achieve the required target strengths underground. In this case study, the various design challenges faced and lessons learned are documented which led to the successful retrofit of the paste plant in 2019.

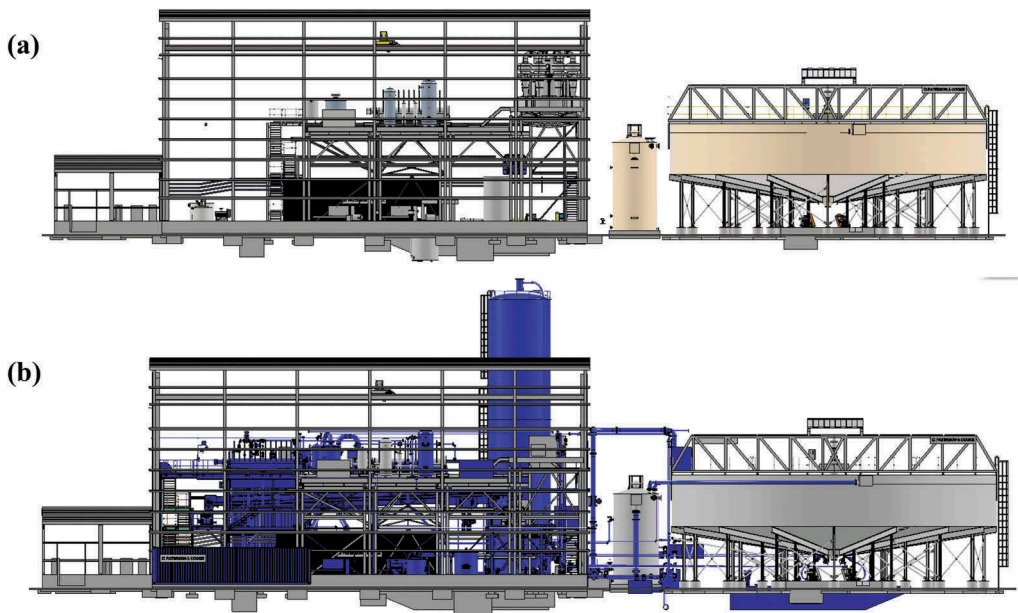
Figure 4. Comparison between (a) Existing 3D model and (b) As built 3D model (new equipment shown as blue).

The existing paste plant was redesigned to produce a cemented paste backfill product to support the mining activities while matching the overall mill utilization of 85 to 92%. A comparison between the existing paste plant 3D model and the as built 3D model complete with the new retrofits is presented in Figure 4.

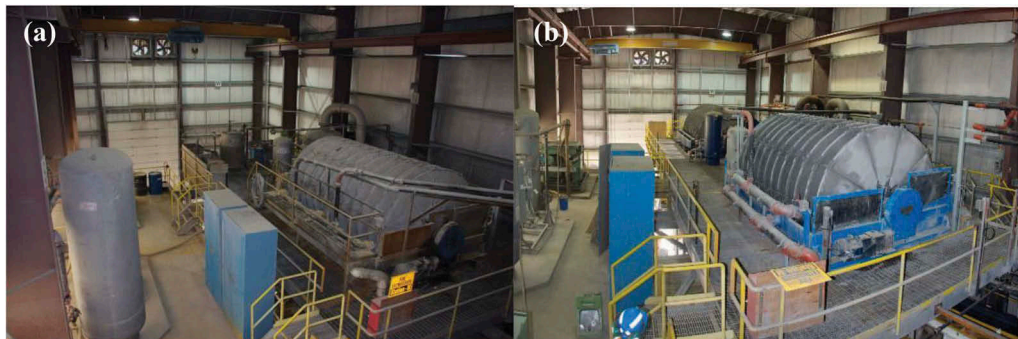
Figure 6. Comparison between (a) Existing filter level layout and (b) Retrofit filter level layout.

The support structure was extended to support the second filter (Figure 5 & 6). The existing flocculant plant was moved to where the cyclone underflow tank was located previously while the existing west staircase was moved over against the west side of the building. The new structure allows top access to the filter feed tank and agitator.
