Monitoring the In Situ Performance of Cemented Paste Backfill at the Lucky Friday Mine

National Institute for Occupational Safety and Health, Spokane Mining Research Division, Spokane, Washington, USA

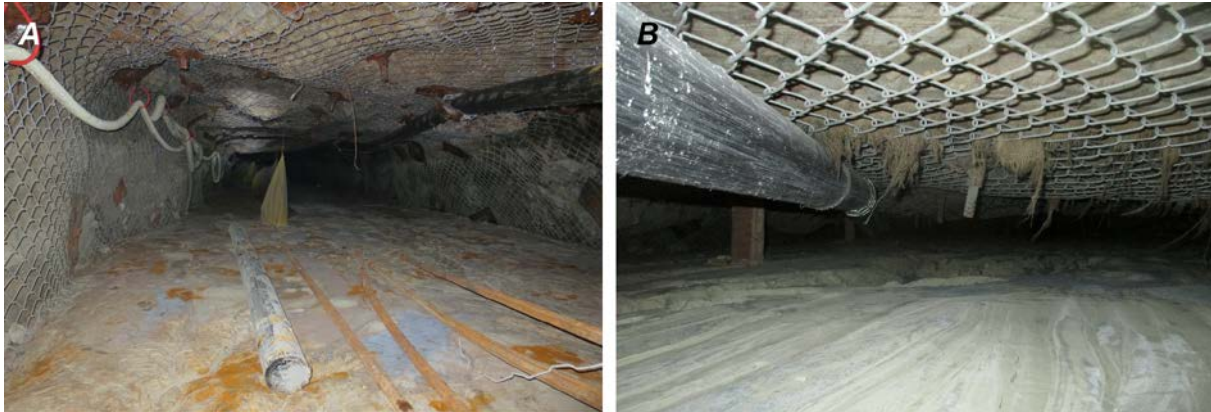
Figure 3. Gap between consecutive backfill levels: (a) 1-m (3-ft) gap above the 5550L-11E stope and (b) 0.3-m (1-ft) gap above the 6350L-15W stope

backfilling process creates a reinforced backfill beam, having a thickness of about 2.4 to 3 m (8 to 10 ft), and intentionally produces a void or gap, approximately 0.3 to 1 m (1 to 3 ft) in height, between the upper surface of the backfill pour and the bottom surface of the previously filled cut (Figure 3).

As noted in Figure 3, cemented paste fill was placed in the 11 stope with a 1-m (3-ft) gap above the backfill, whereas in the 15 stope, the paste fill was poured leaving only a 0.3-m (1-ft) gap above the fill. Although the response of the 11-stope and 15-stope instruments is similar, strain hardening is expected to occur in the 15-stope backfill after much less closure. Future measurements from these instruments will hopefully provide an important quantitative assessment of the effect of gap height on fill behavior and thus, help optimize the paste fill's ability to provide regional support and minimize strain bursts.
